**Risk Reduction Actions**  
**for Substandard or Impaired Tailings Facilities**

November 2004

**Report of Workpackage 4.4 of the RTD project**

***Sustainable Improvement in Safety of Tailings Facilities (TAILSAFE)***

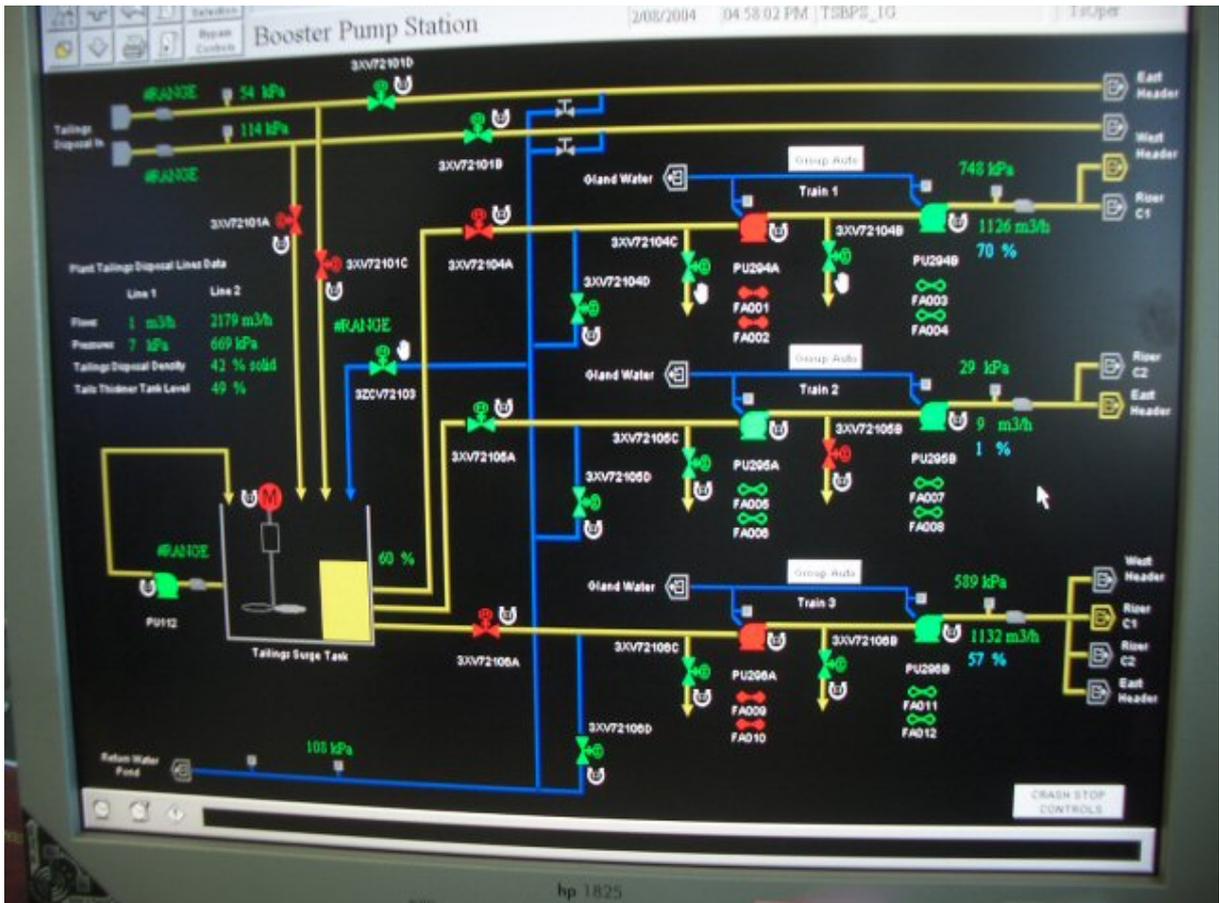
**Figure 1: Online computer monitoring system for a tailings impoundment**

Modern tailings impoundments in countries with guidelines and legislation have sophisticated monitoring equipment to assess the operation of the tailings facility, pipelines, return water, and treatment. Commonly these online monitoring systems (see Figure 1) are connected to the processing plants online systems to assess the entire water cycle of the mining operation. This allows a mill manager or senior engineer up to date information on the available water stored in the tailings facility, decant ponds, open pits etc... This sophisticated system can also act as a money saving feature to allow shut downs of remote borefield pumps which can be more costly (depending on distance pumped) than returning free water from a tailings pond.

The online monitoring systems can tell an operator in real time when, and with some systems where, a pipe burst or pump failure has occurred. Simple magnetic flow meters determine the flow in the tails pipe at the plant and along the various lines to the impoundment. Any difference in flow indicates a burst pipe (or broken spigot) which alerts the operator to take action.

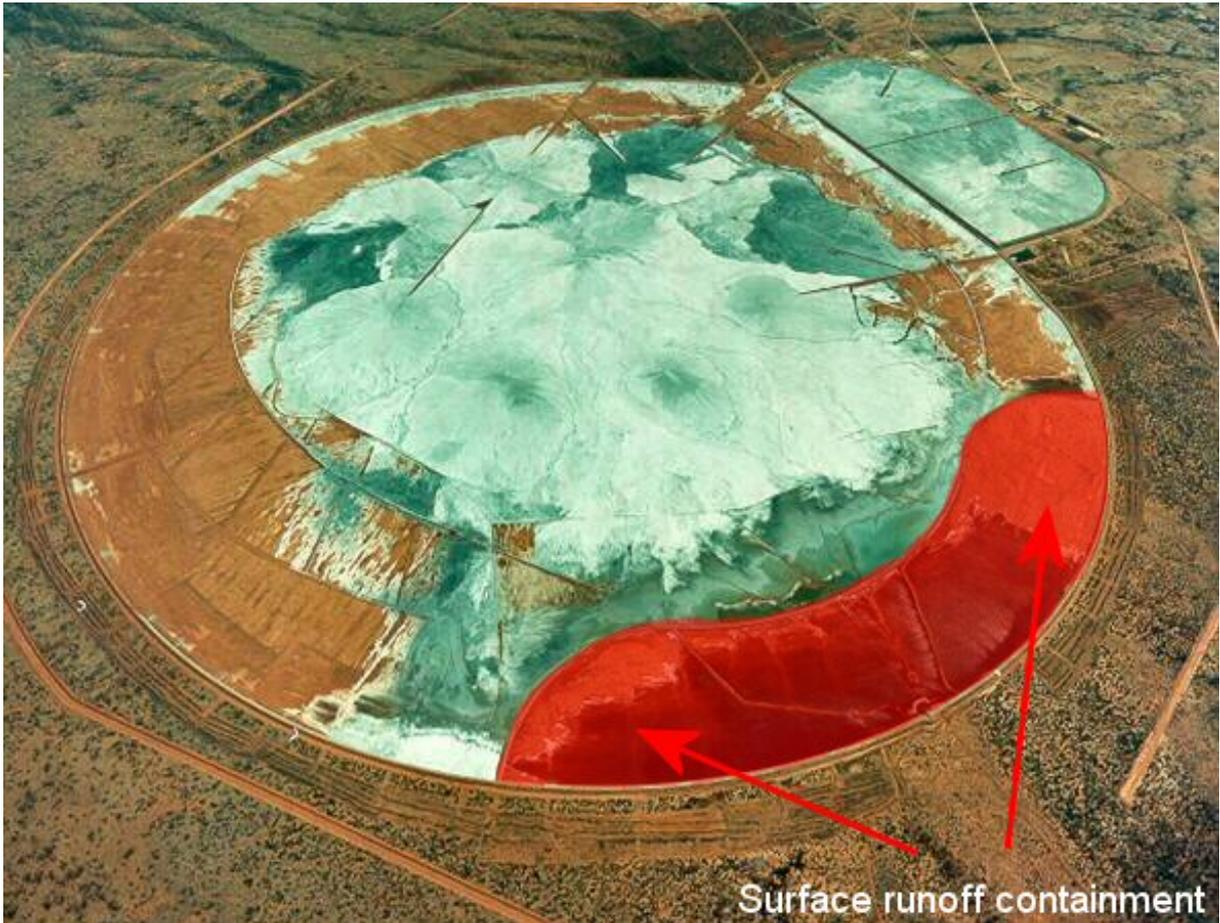
**Figure 2: Containment zone for surface runoff and tailings water.**

back to the plant. Free water stored with the tailings in a conventional impoundment can be lost through evaporation and seepage. If a storm occurs over a paste or thickened site the collected ponded water is normally held for long period of times to provide the processing plant with water, reducing borehole pumping and/or groundwater treatment costs (see Figure 2).

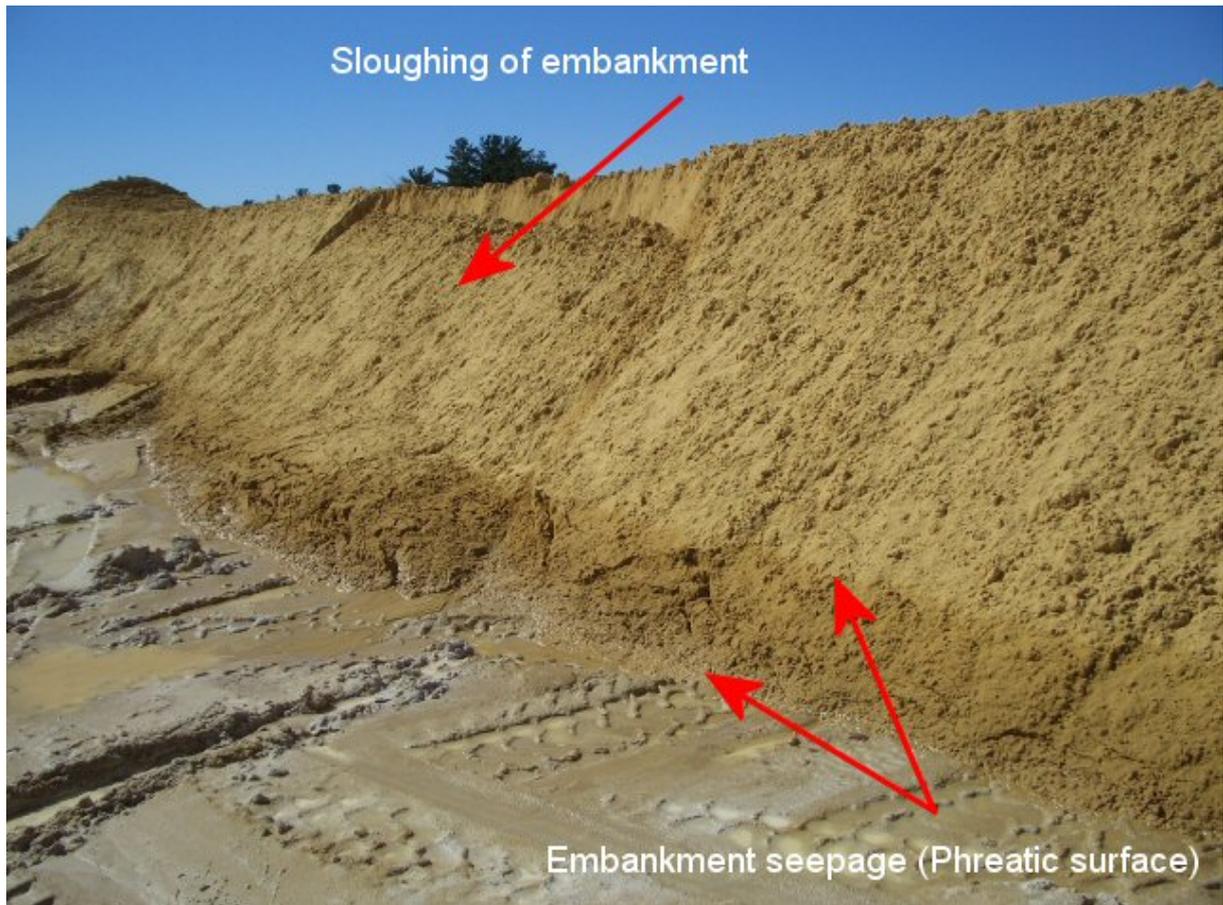
**Figure 3: High phreatic surface causing sloughing of a tailings embankment.**

Figure 3 shows a tailings embankment saturated at the toe and sloughing as a result of the phreatic surface and steep embankment angle.

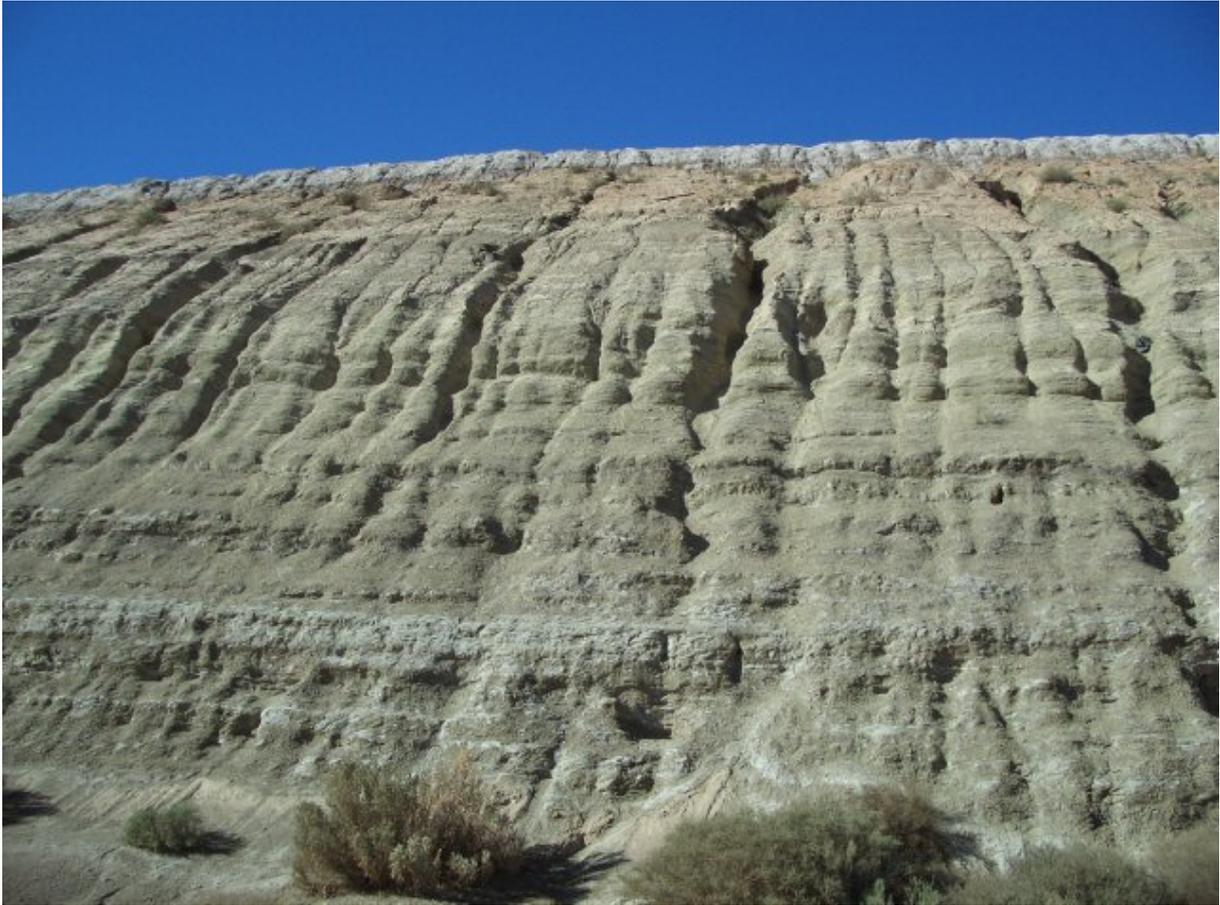
**Figure 4: Wind and water erosion on the downstream face of a tailings embankment.**

Wind and water can erode the dry impounded tailings or more importantly erode the embankment(s) of a tailings facility (see Figure 4). Over time channelling from water runoff can cut into the embankment and wind can pick up loose material from the down and upstream faces.

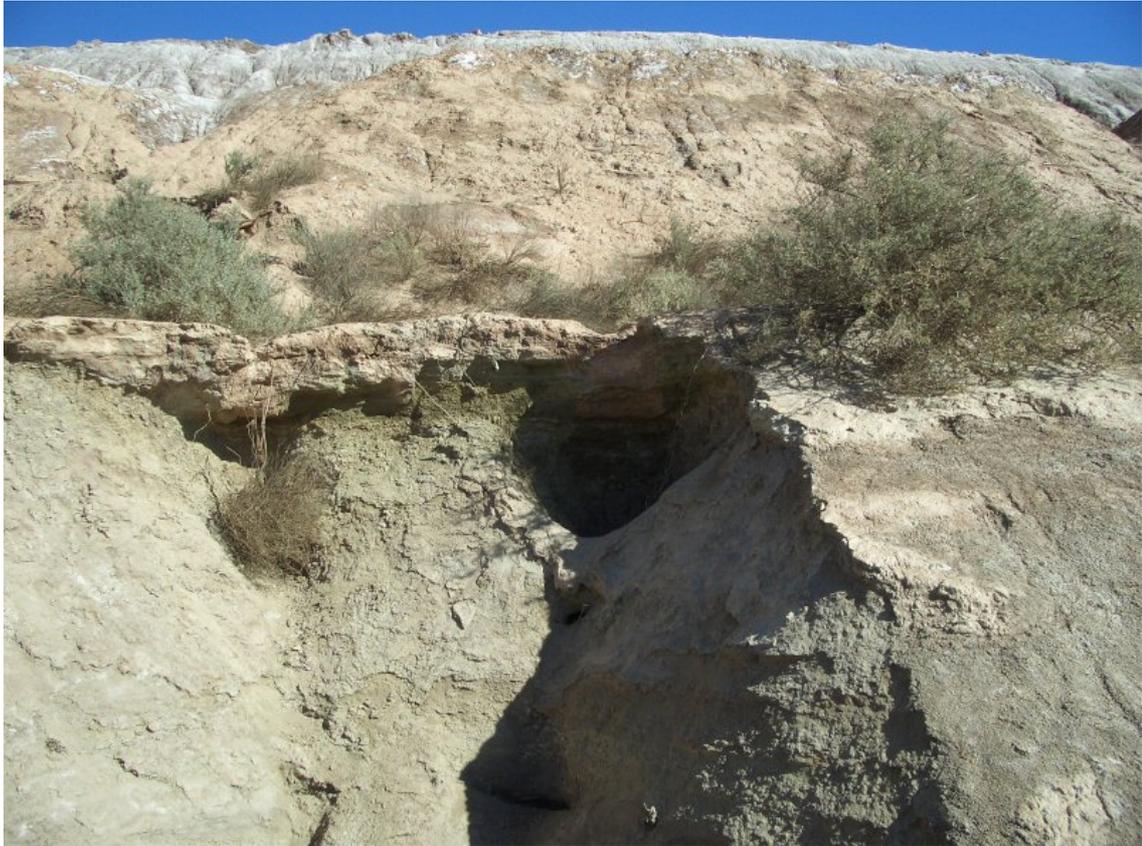
**Figure 5: Piping failure and subsequent erosion on a downstream face.**

Water erosion is not specific to rain waters eroding the embankment, but also the water that can flow down a face from overtopping (see Figure 7). Internal erosion is also a problem particularly where seepage exits through the downstream face (commonly from piping failures - see Figures 5 and 6) and erodes the embankment.

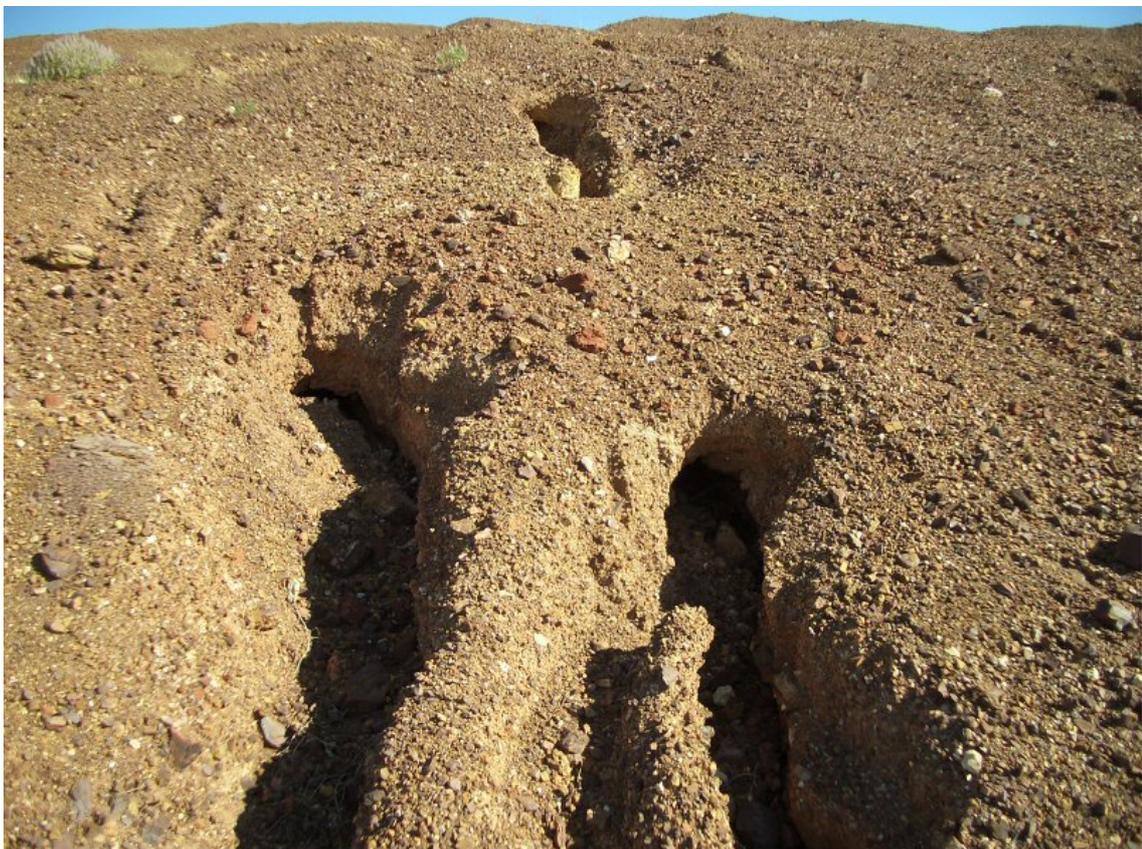
**Figure 6: Multiple piping on a downstream face with mine waste rock strengthening.**

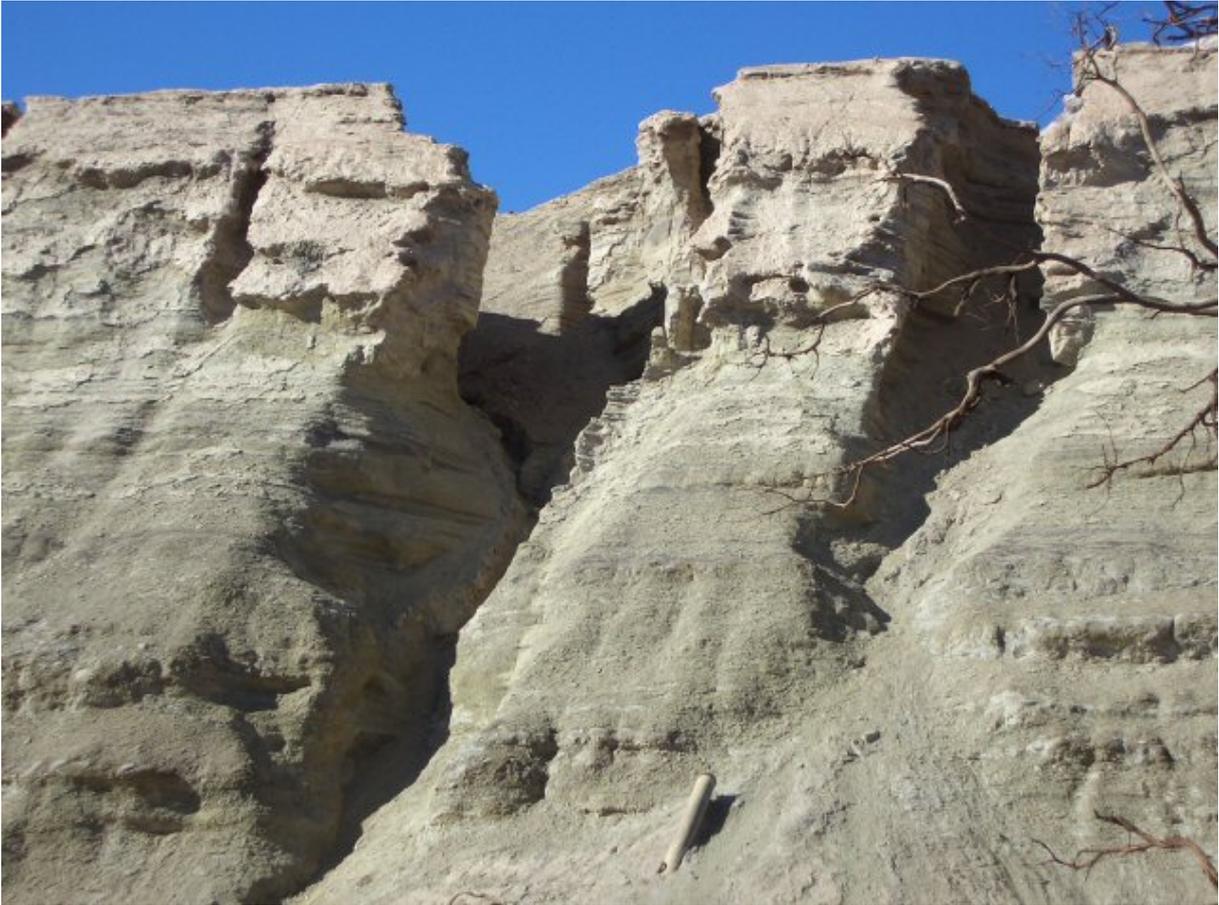
**Figure 7: Extensive water erosion (channelling) on a downstream face of a tailings embankment.**

Berms can be constructed on the downstream face to lessen the erosion of water by dissipating the energy. Fast running water can lead to rapid channelling as has been seen in many overtopping failures cutting into the embankment face causing slope instability (see Figure 7).

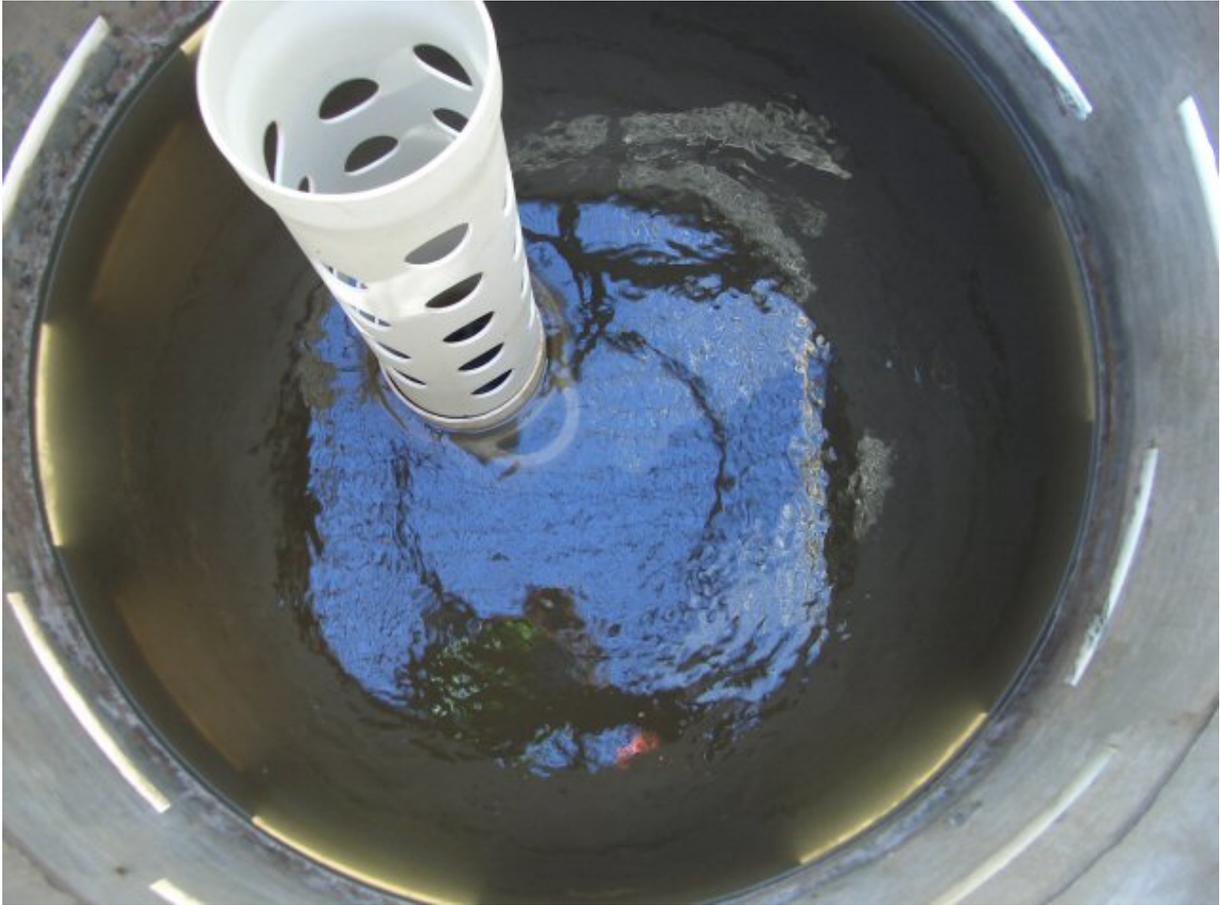
**Figure 8: Decant tower and submerged collars in concrete housing.**

If there is too much water in the impoundment collars can be removed from the tower to increase the outflow of the conduit (see Figure 8). Heavy lifting equipment may be needed if the collars are encased in tailings or have become lodged in position. Care should be taken not to impose stress on the pipe joints below the tower where the conduit travels towards the outside wall.

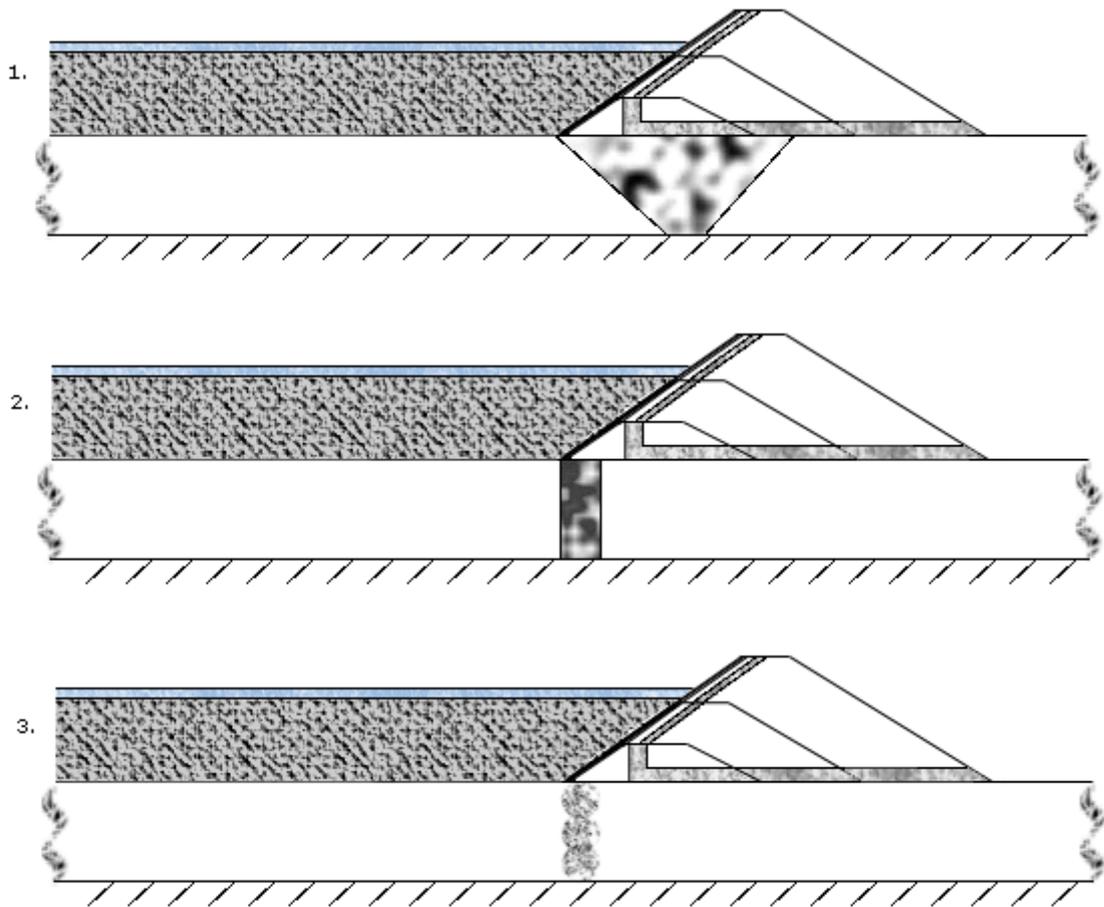
**Figure 9: Embankment barriers, (1) – Cut-off trench, (2) – Slurry Wall, (3) – Grout curtain.**

There are two main methods used to control groundwater seepage from a tailings impoundment. These are return and barrier systems. Seepage barriers prevent the mobilisation of seepage through the base of the embankment and are generally installed from the ground surface down to a less permeable or impermeable material or rock. The seepage is thus contained below the impoundment forcing future seepage back through the tailings to the free pond. Typical seepage barriers are cut-off trenches, grout curtains and slurry walls. More details of these barriers are mentioned in TAILSAFE WP1 and are shown in Figure 9.
